The Forehead & Cheeks

Product Code: CSM-2512 Rev.11 06/23

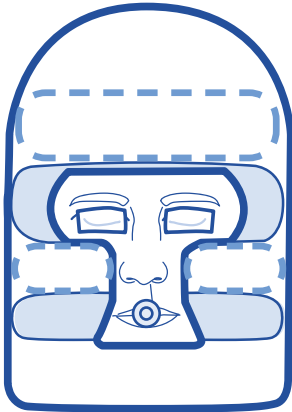
- + Ensure the patient's face is supported on the bony part of their cheeks, not the soft tissue
- + Ensure the patient's eyebrows are clearly visible
- + The face support must not encroach into the periorbital area above or below the eye
- + Recheck the head support after turning the patient and at least every 30 minutes throughout the procedure
- + It may be necessary to lift and replace the patient's face during long procedures or if there has been movement
